MKO	MAP TITLE: <b>Subsoil Map</b>		MAP NO.: <b>Figure 4.1</b>	SCALE: <b>1:25,000</b>
	PROJECT TITLE: <b>Phase 1 - Galway Inner Harbour, Galway</b>			DATE: <b>03-10-2019</b>
	DRAWING BY: <b>Eoin O'Sullivan</b>		CHECKED BY: <b>Michael Watson</b>	
	MKO, Tuam Road, Galway, Ireland, H91VW84. Email: info@mkofireland.ie Tel: +353 (0)91 735611		ISSUE NO.: <b>190532-2019.10.03-D1</b>

**Phase 1 – Galway Inner Harbour, Galway**

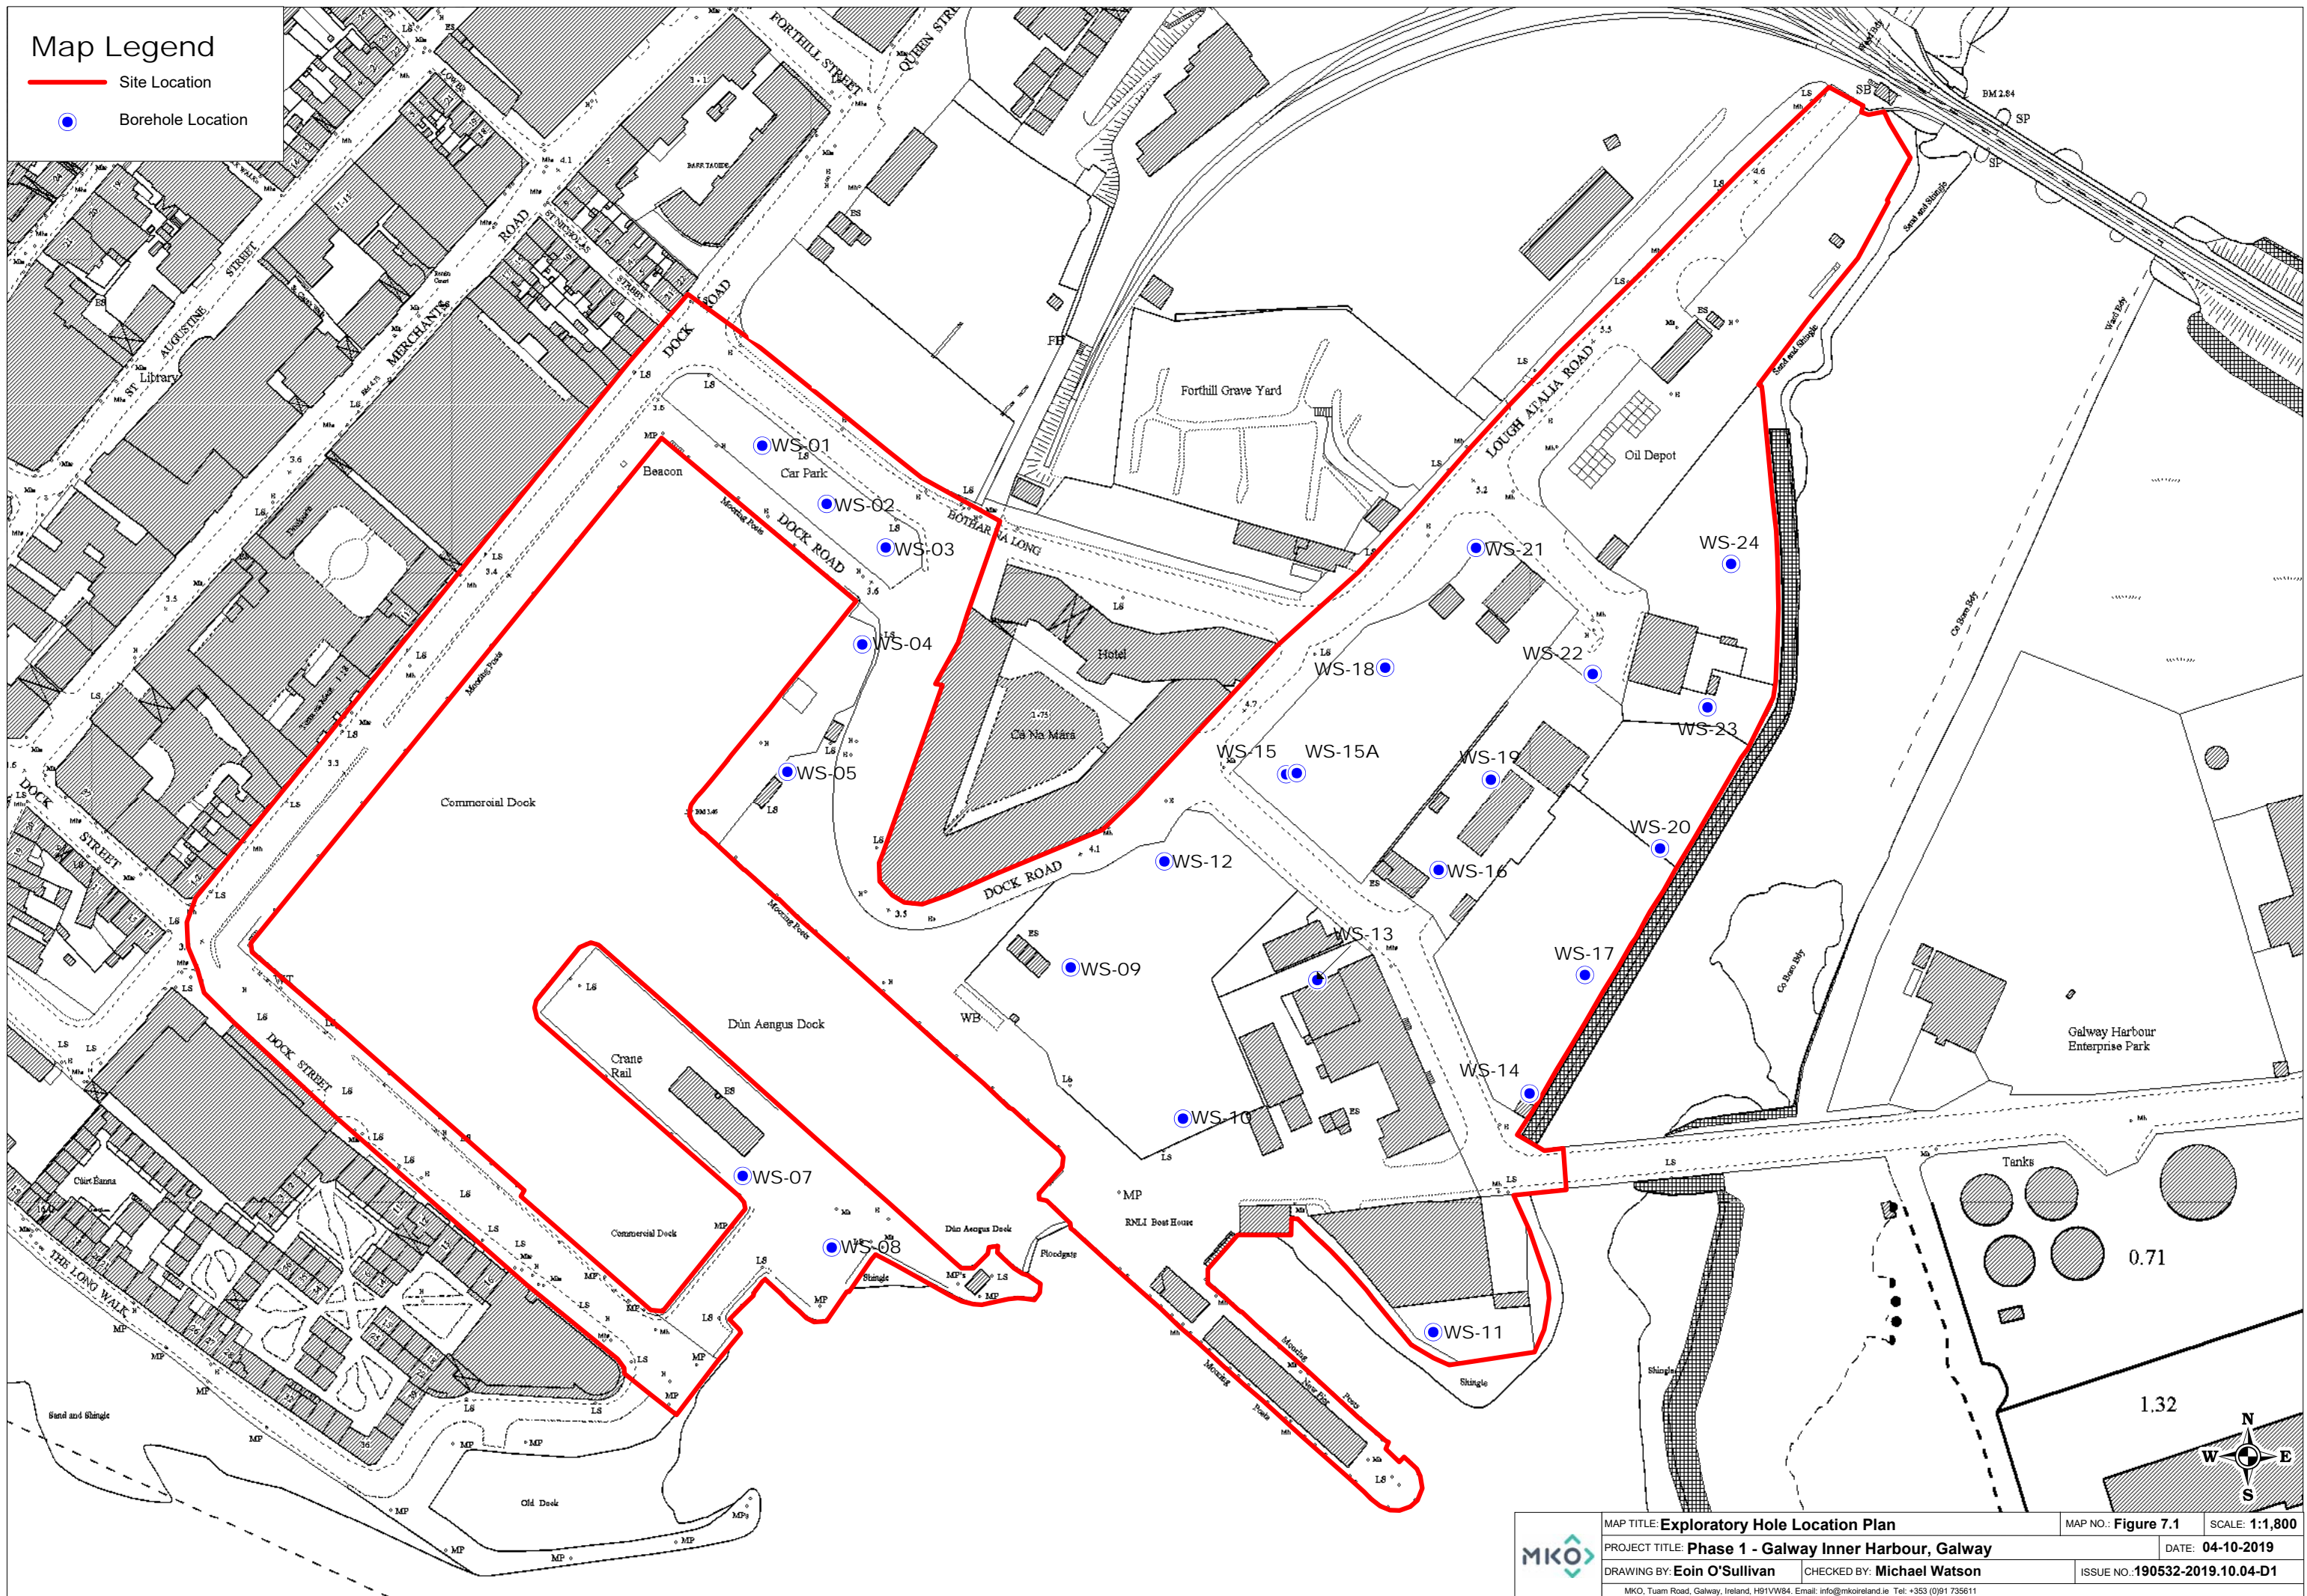
As can be observed from Table 6.2 of Appendix 6, elevated concentrations of lead, benzo(a)pyrene, benzo(b)fluoranthene and dibenzo(a,h)anthracene have been identified within the Made Ground across the site, which pose a risk to human health.

The result from the quantification testing indicates that the areas of Made Ground where asbestos was identified in window sampler boreholes WS-10 between 1m and 2mbgl and WS-18 between 0m and 2mbgl were below the hazardous threshold of >0.1% asbestos by weight.

In addition, a number of the window sampler boreholes refused at shallow depths within the Made Ground and therefore it will be necessary to undertake further investigation by means of rotary or cable percussive drilling to understand the ground conditions at depth. It will also be necessary to install groundwater monitoring wells in order to characterise and assess the groundwater at depth.

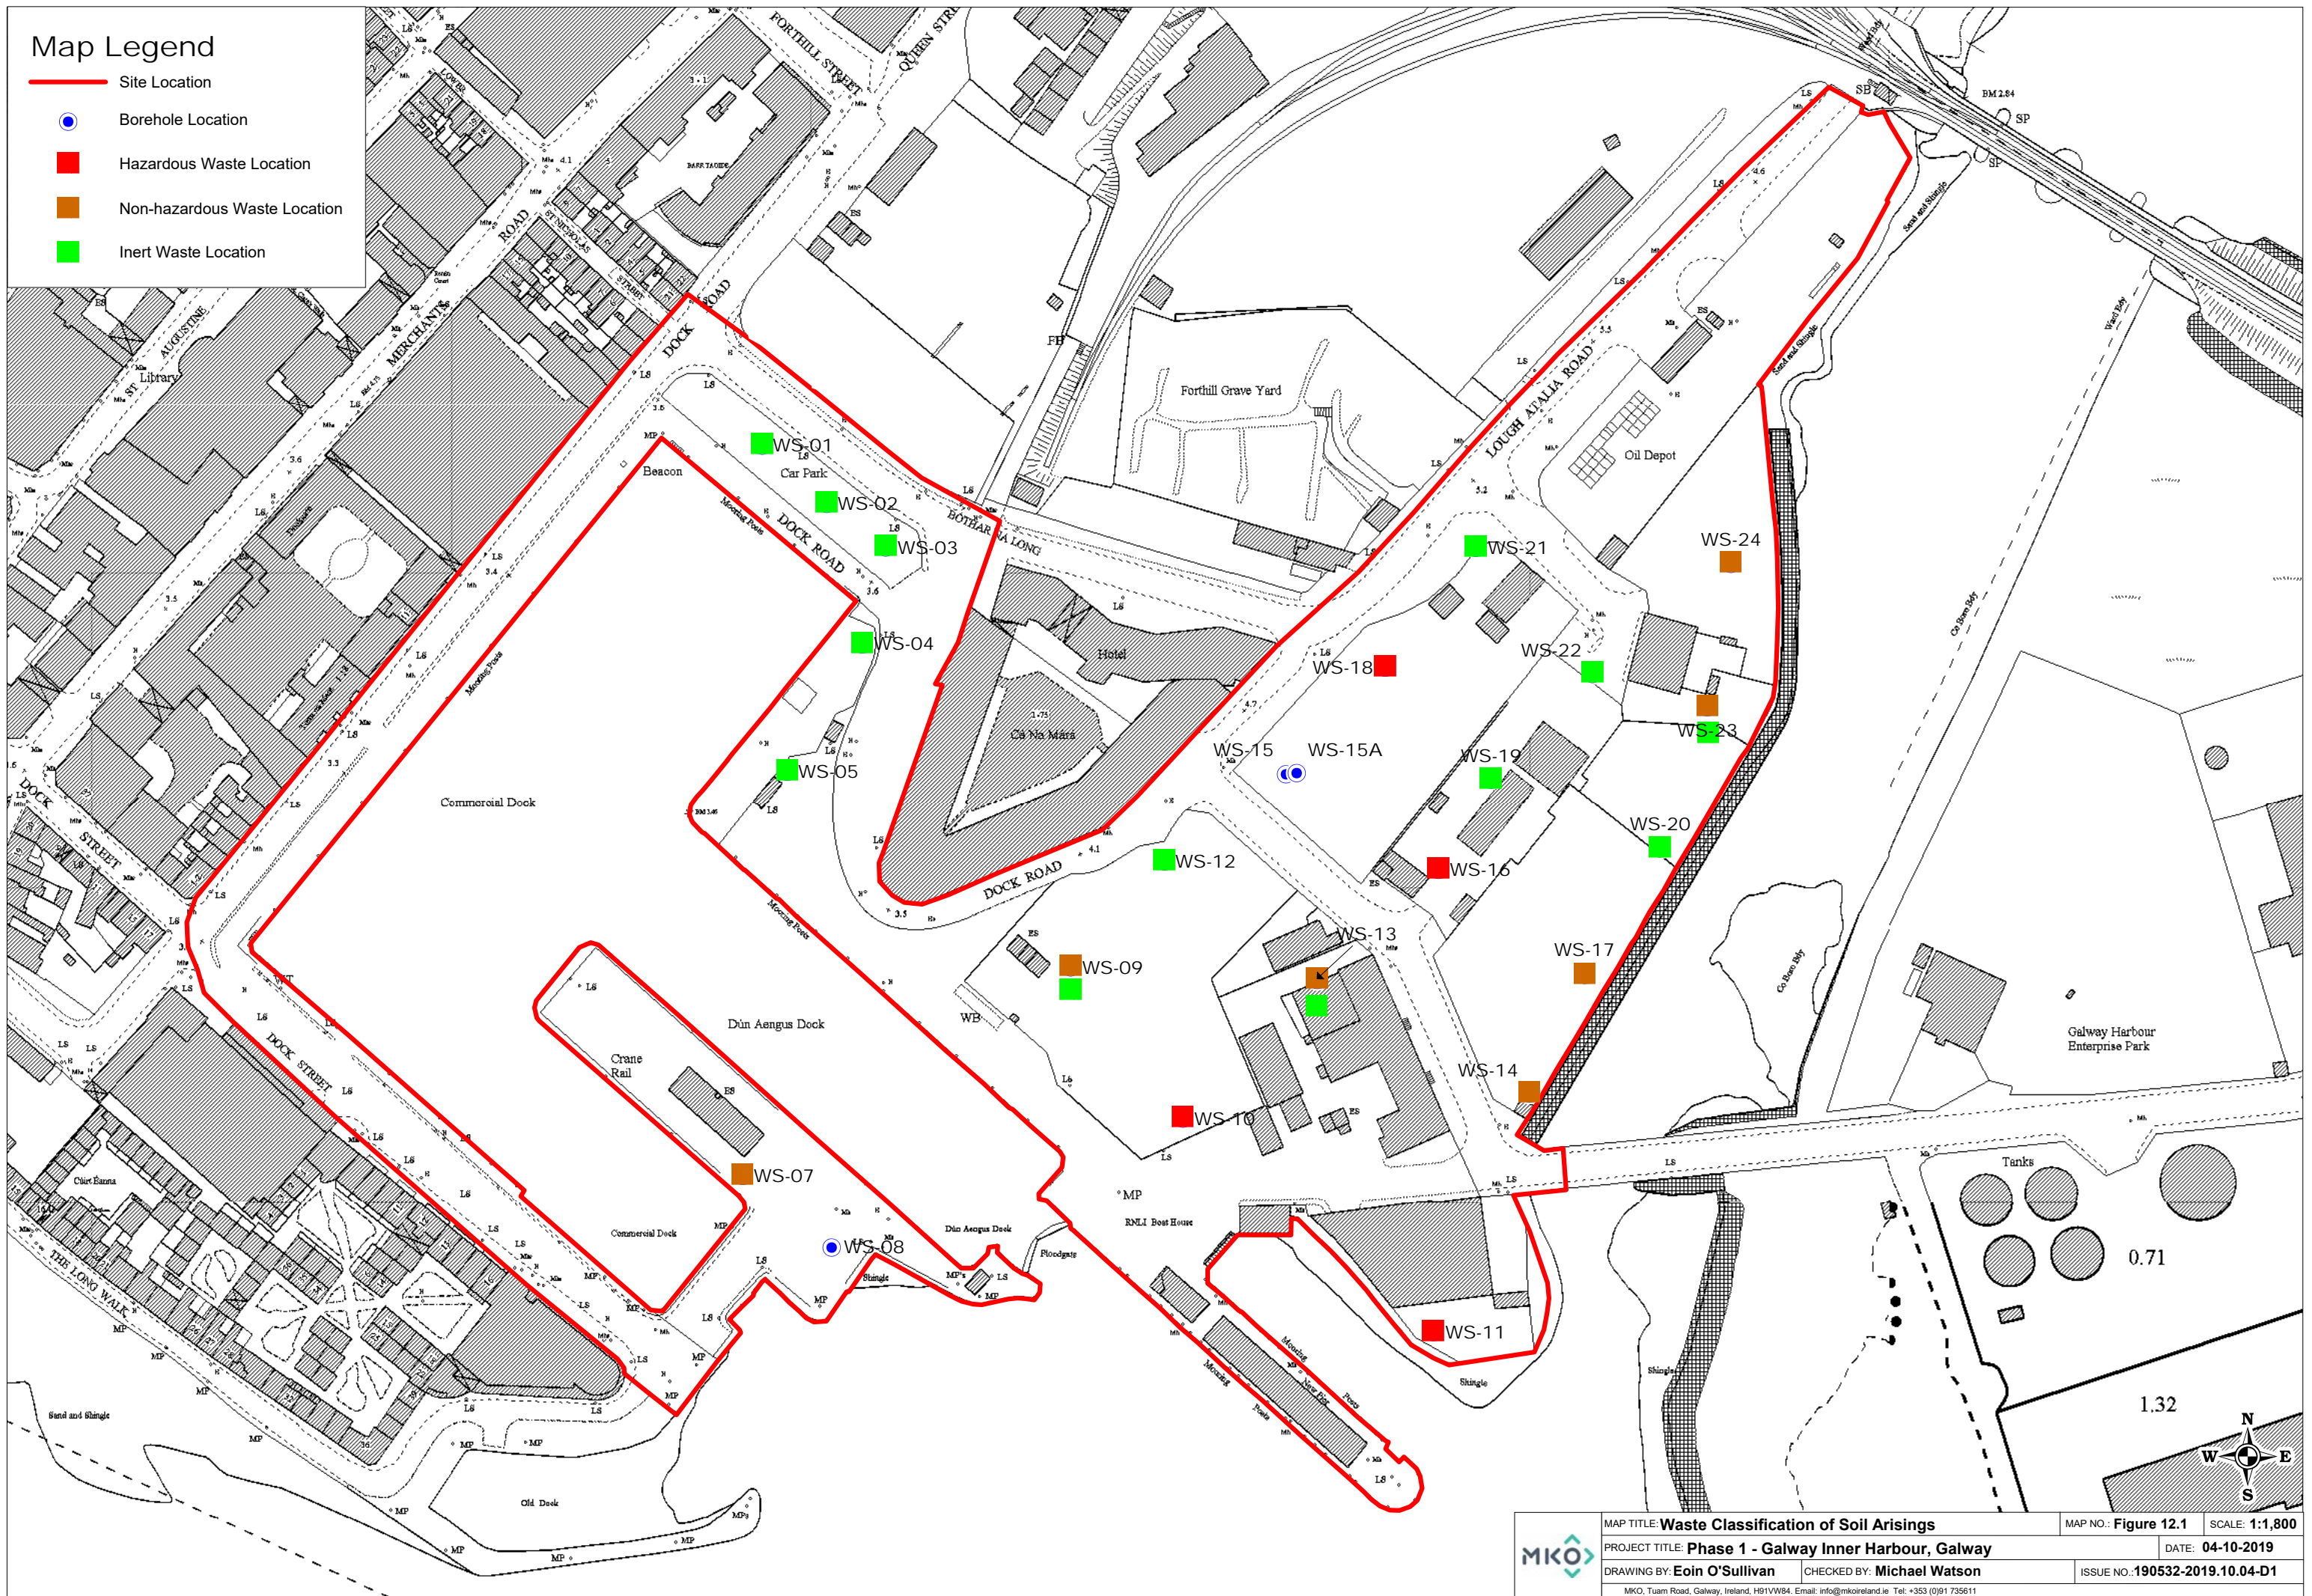
An assessment of the soil for waste classification purposes (see Table 9-5) indicates that of the thirty one Made Ground and four soil samples tested by Element on behalf of MKO, seven samples would be classified as hazardous and twenty eight samples would be classified as not-hazardous (i.e. inert or non-hazardous) for waste recovery/disposal purposes.

Where offsite recovery or disposal is required, the available laboratory results indicates that of the thirty one Made Ground and four soil samples tested, seven samples would be classified as hazardous and twenty eight samples would be classified as not-hazardous (i.e. inert or non-hazardous) for waste recovery/disposal purposes.

It may also be possible to dispose of the non-hazardous material to a licensed soil waste recovery facility, where disposal does not incur landfill tax. This should be discussed with a suitable facility.
