Exploratory Hole Location Plan

Galway Inner Harbour, Galway

5. GROUND AND GROUNDWATER CONDITIONS

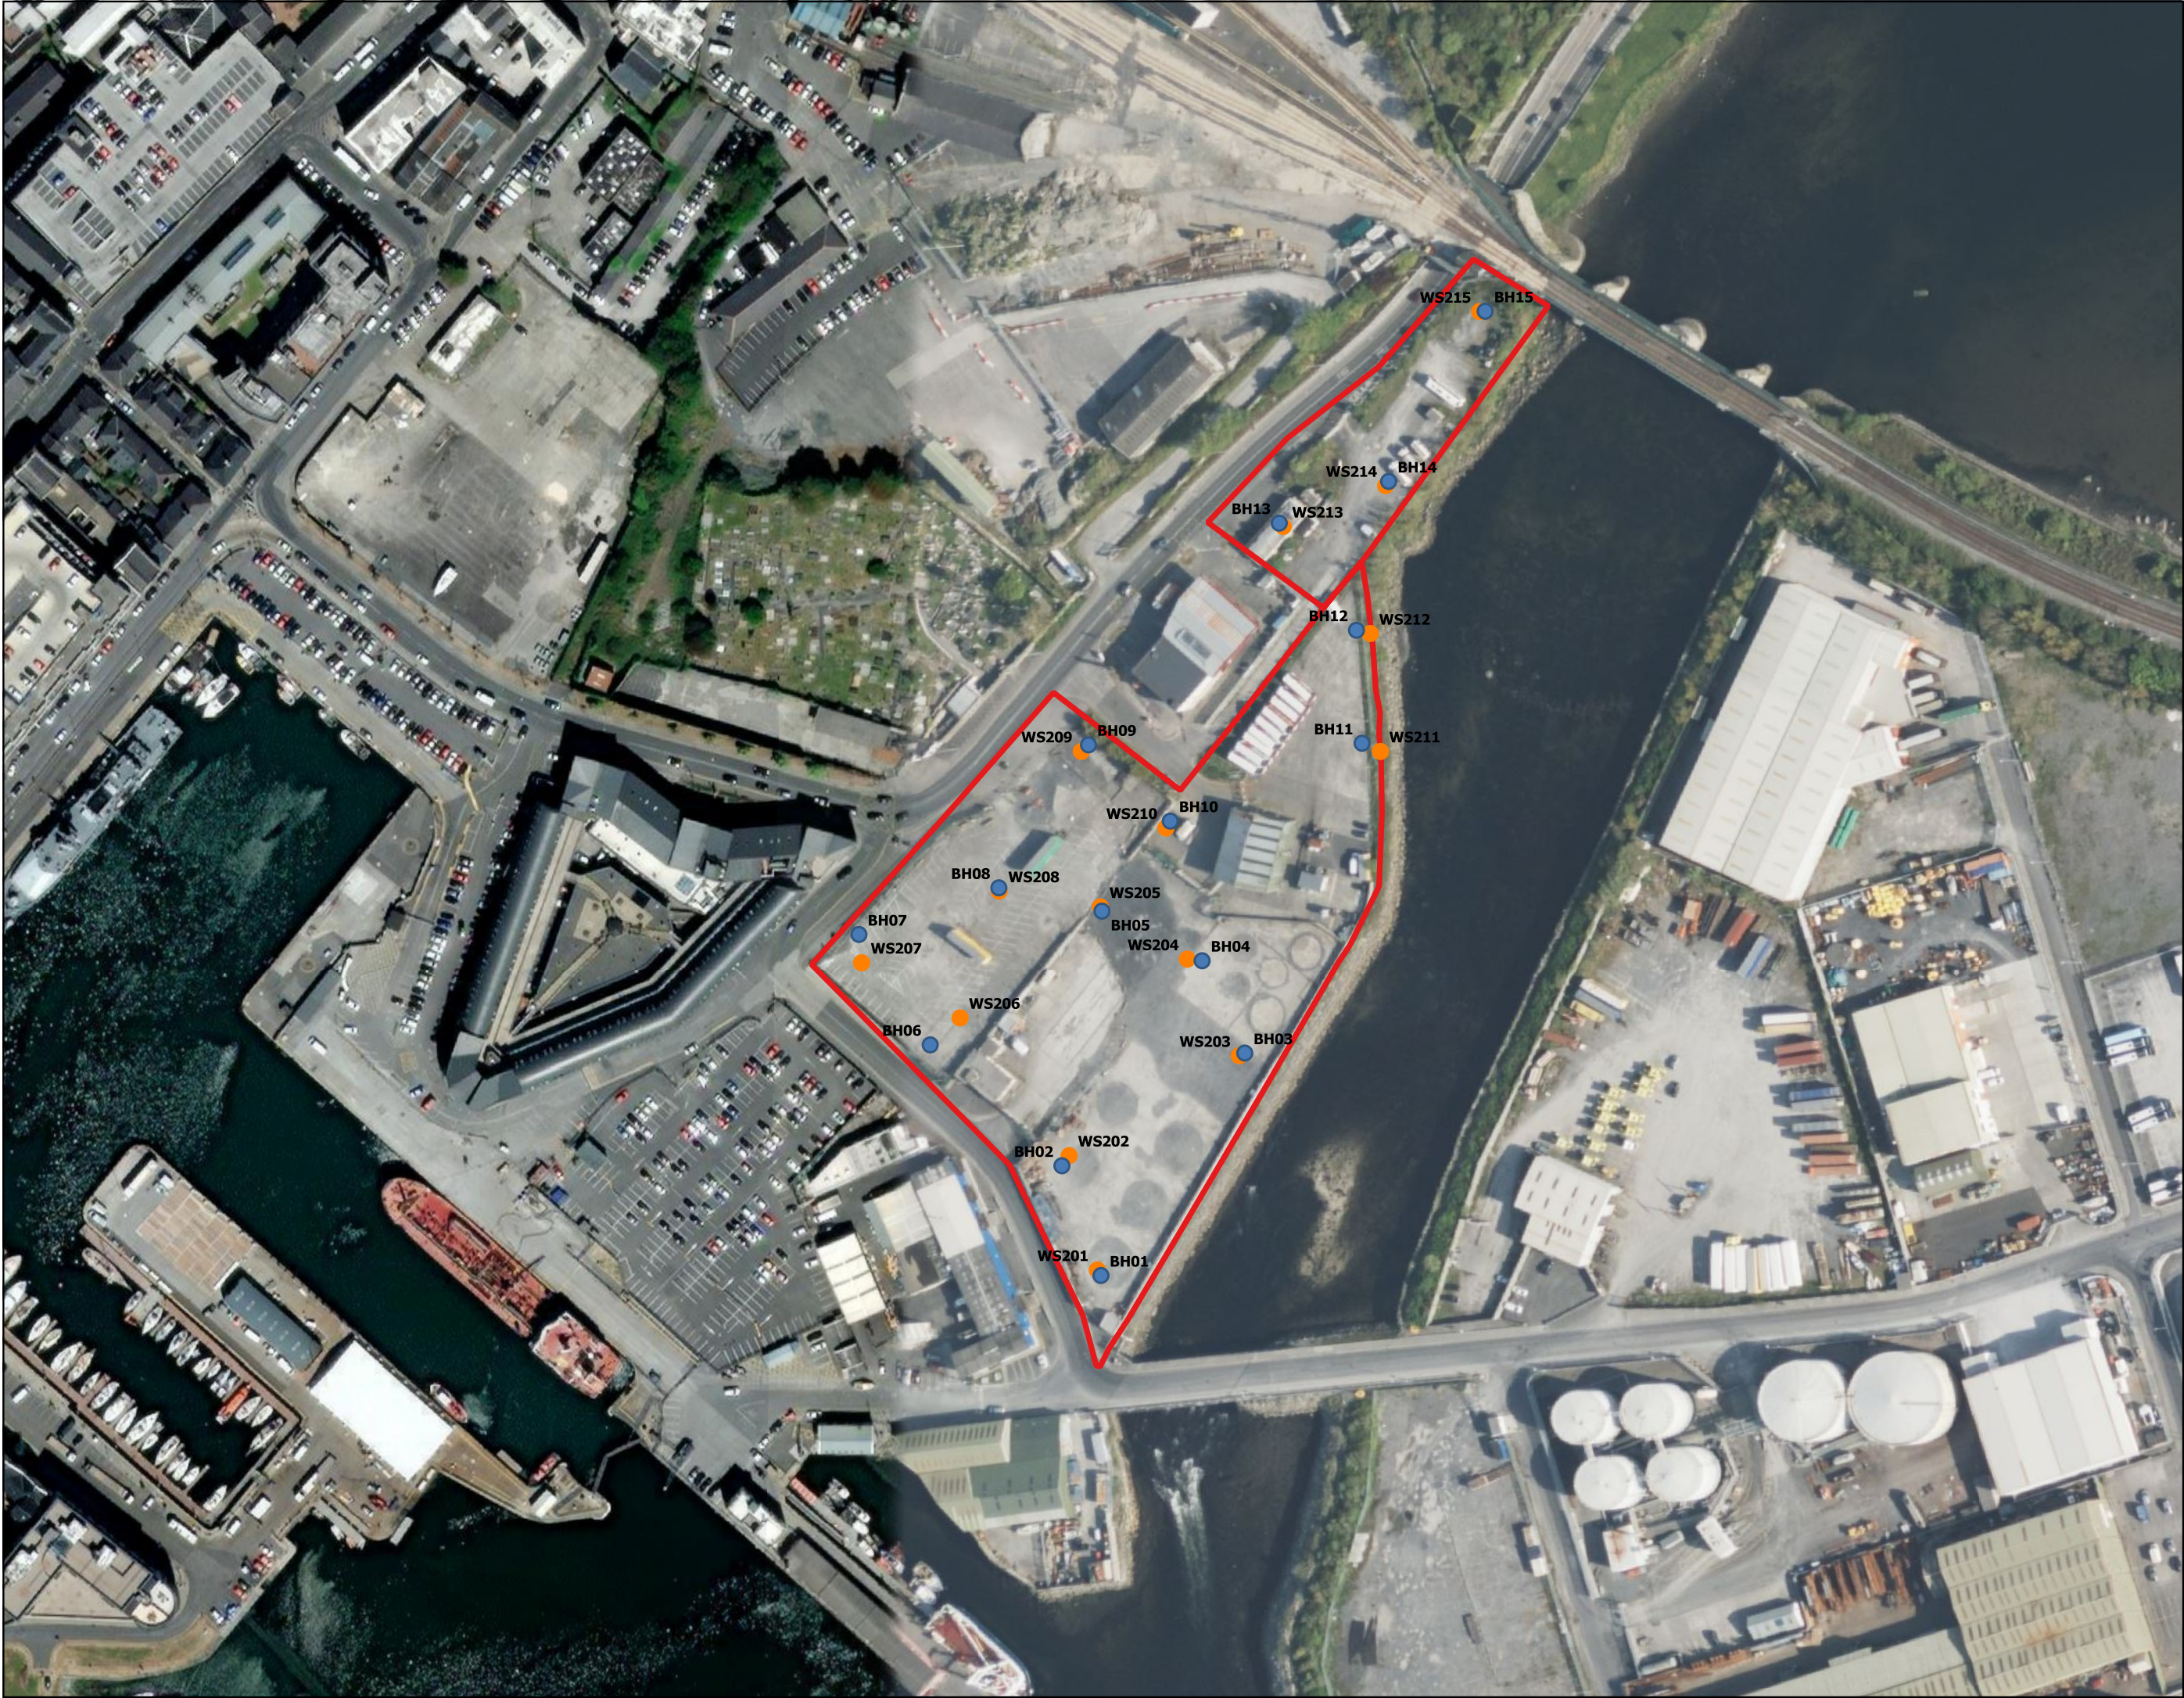
Drawn By	EOS	MW	
Project No.	220628	Drawing No.	4-1
Scale	1:1,800	Date	2022-11-14

- Site Location
- Rotary Borehole Location
- Window Sampler Boreholes

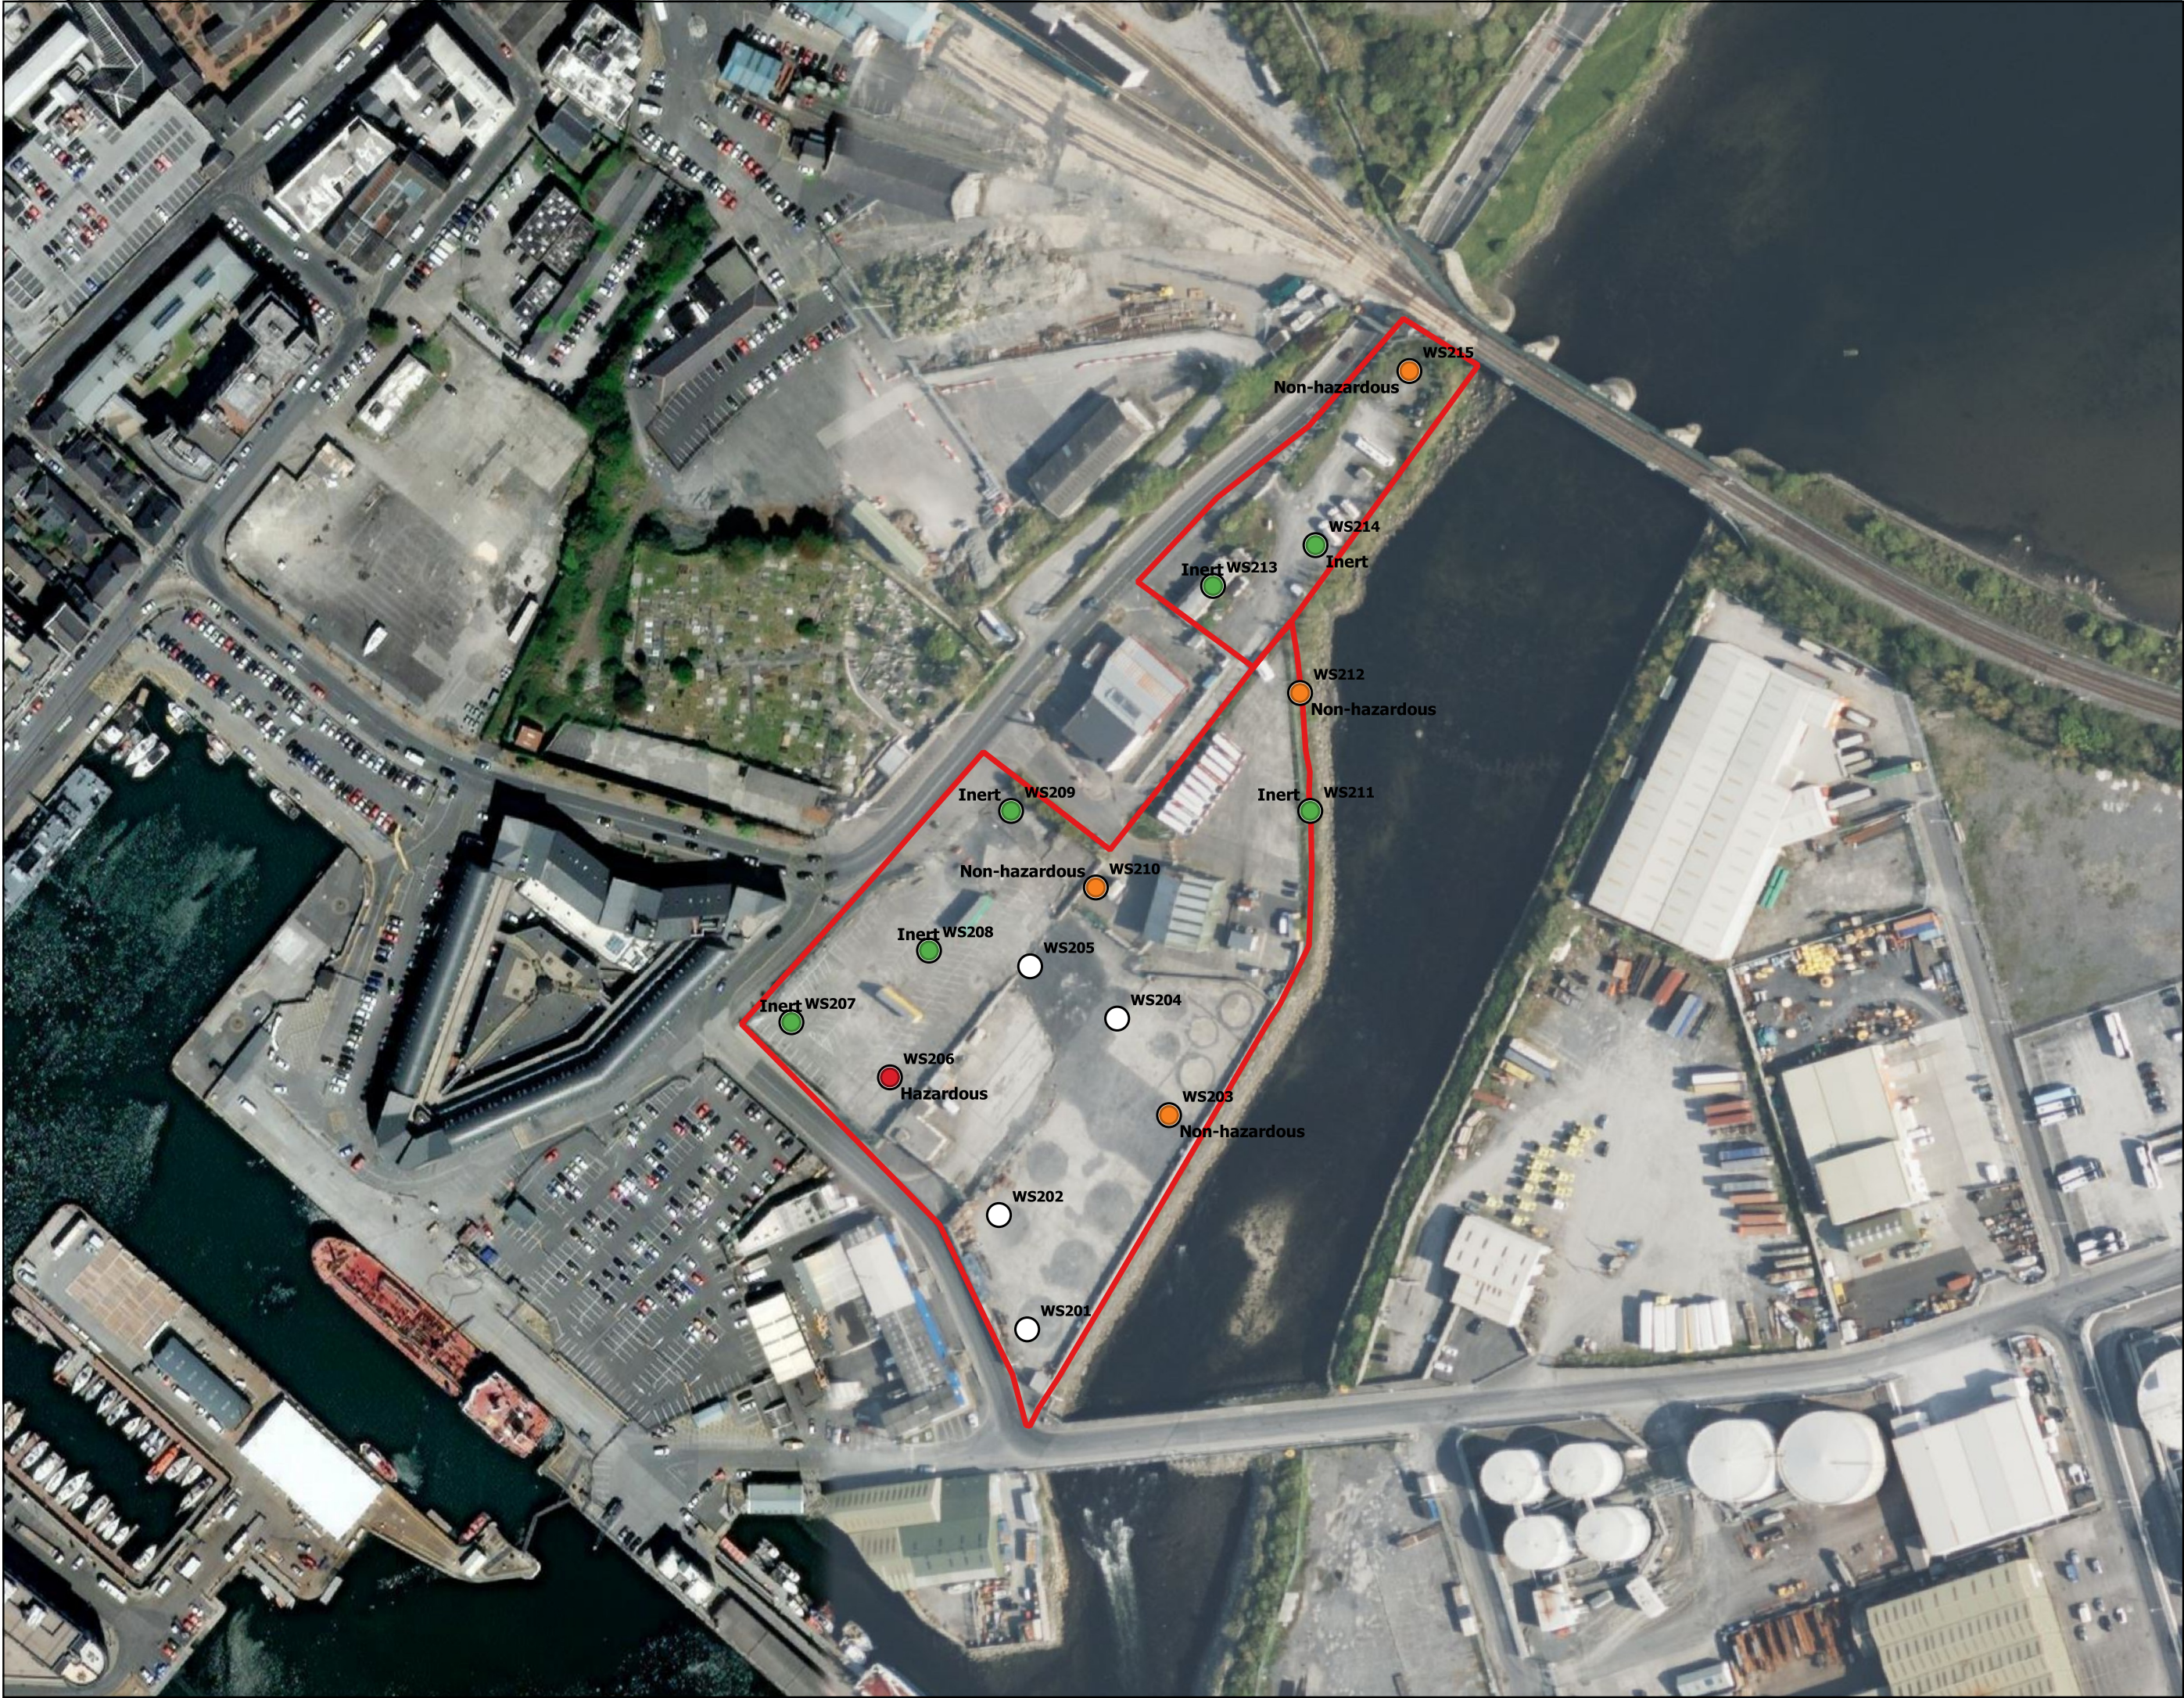
- Site Location
- Hazardous Waste Location
- Inert Waste Location
- Non-hazardous Location
